Assessment & Sustainable Replacement Options

155 George Street, Prince George, BC

Presented to: Regional District of Fraser-Fort George (RDFFG) Prepared by: McCuaig & Associates Engineering Ltd. Date: February 20, 2024

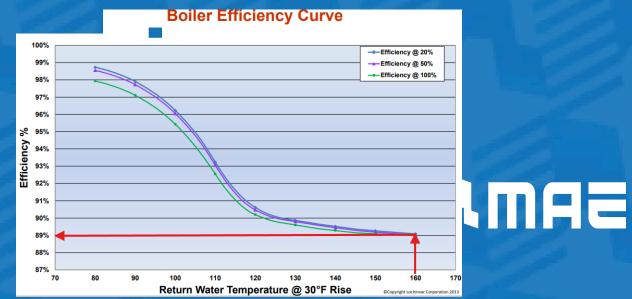
- 6 condensing boilers, ~270 MBH each
 - 2 IBC boilers installed in 2021. Good Condition
 - 1 Lochinvar installed in 2021. Good Condition
 - 3 HydroTherm boilers original to the building. Poor condition
- Issues:
 - Operating at non-condensing temps (~180°F).
 - Coupled DHW prevents lower return temps.
 - Three boilers used only for backup in extreme cold.

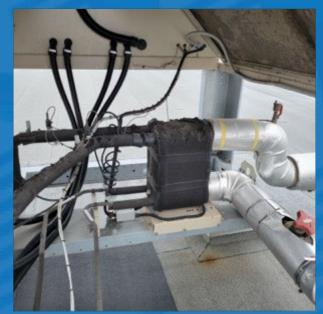
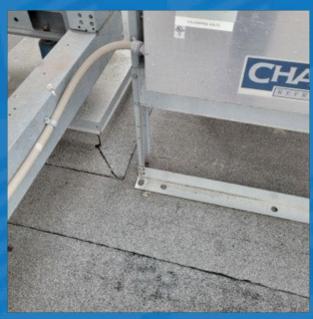
- 50-ton Daikin chiller installed in 2016 Good Condition
- Fluid cooler from 2007 (near end of life) Acceptable Condition
- Issues:
 - Chiller pipe and HX insulation are damaged (likely birds)
 - Fluid cooler is not properly fastened

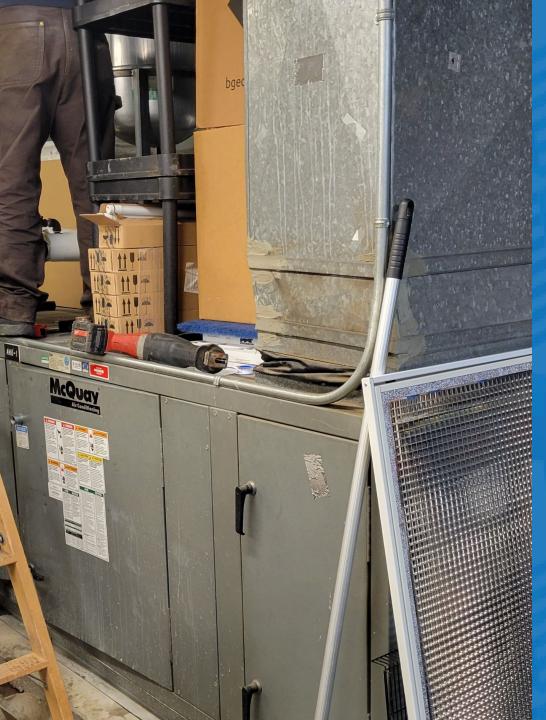
- Single Custom Maid McQuay AHU
- Issues:
 - Originally installed and reached its end of reliable service life
 - Significantly oversized. The unit is 10,000 cfm, while ASHRAE 62.1 (Ventilation in commercial buildings) only requires 3,000 cfm
 - The Oversizing is the reason of the poor performance of the generally well-maintained building

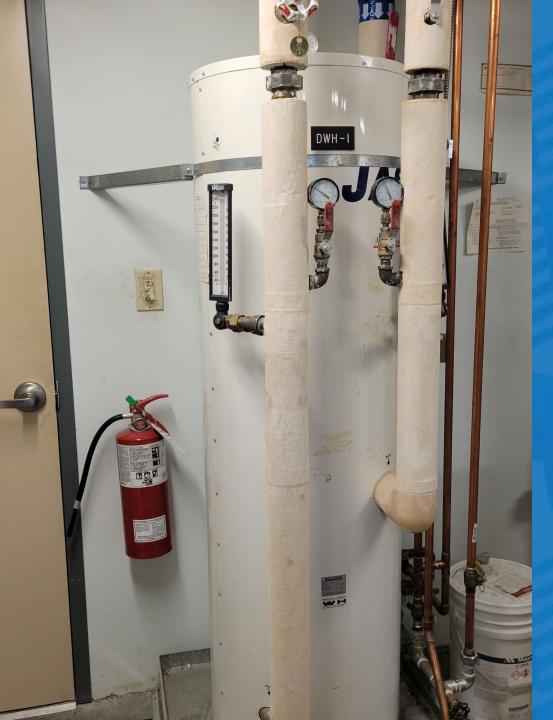
- One storage tank heater by the boiler plant
- One electric tank heater
- Issues:
 - Both reached the end of reliable service life
 - The storage tank is connected to the boiler plant, preventing it from working in a condensing range and decreasing overall efficiency

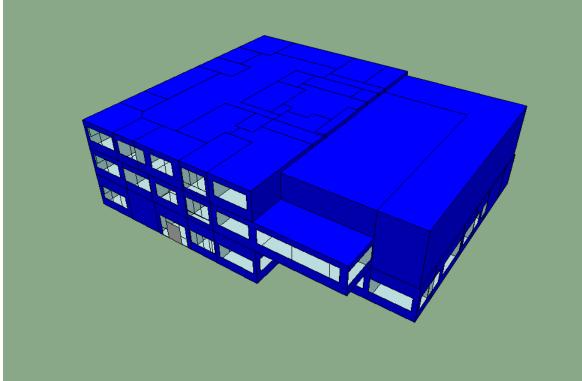
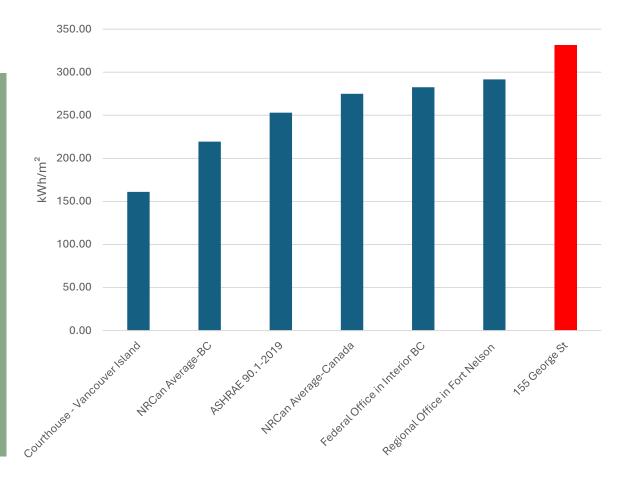
ENERGY MODEL

SCENARIO	BASELINE – UTILITY BILLS	BASELINE - SIMULATED	MAE	CVRMSE
Gas Consumption (kWh)	567,305.81	567,612.10	0.05%	14%
Electricity Consumption (kWh)	375,800.00	365,742.90	-2.7%	5%
