**DEVELOPMENT PERMIT No. 1508**

## Environmental Management Plan (2025–2030) for Future Maintenance, Development and Restoration Activities at Ness Lake Bible Camp - Supplement to the Development Permit Amendment – Non-Delegated

Version: 1  
June 2025

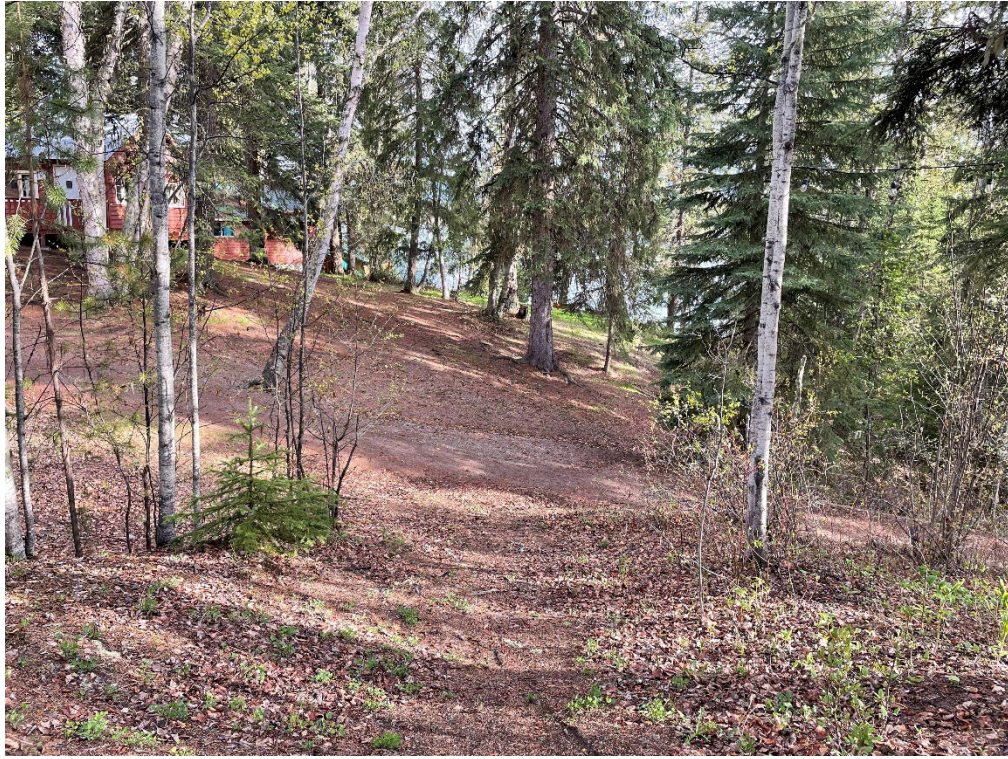
Appendix Photo A-1. Typical view of NLBC grounds around the cabin sites.

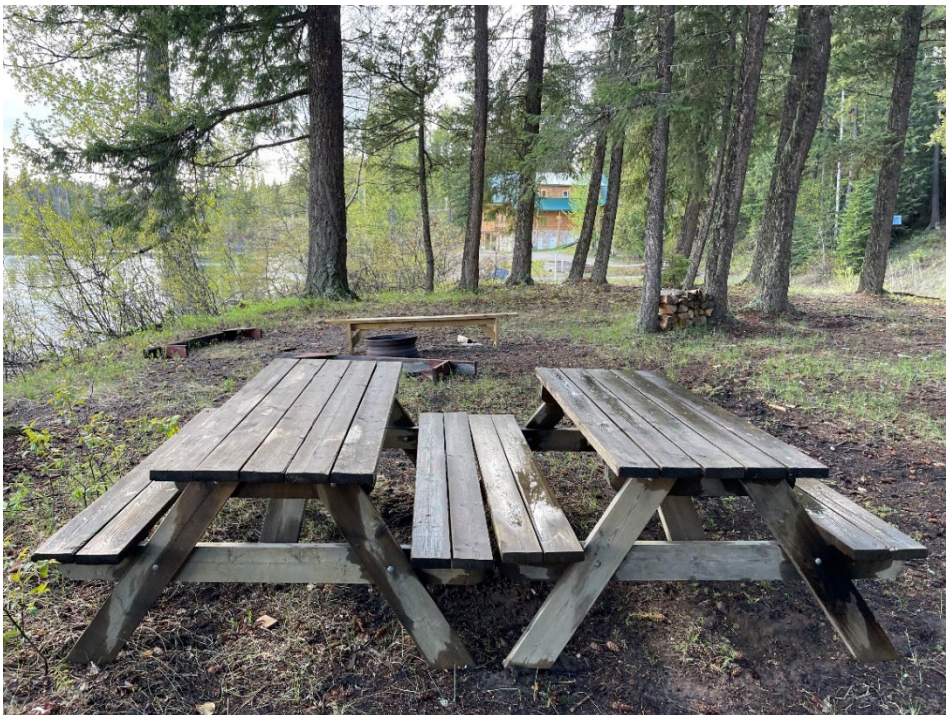
Appendix Photo A-4. Campsite #3 east of the beach. Note the mature Douglas-fir and typical deciduous riparian vegetation that is retained to the crest of the lake bank.

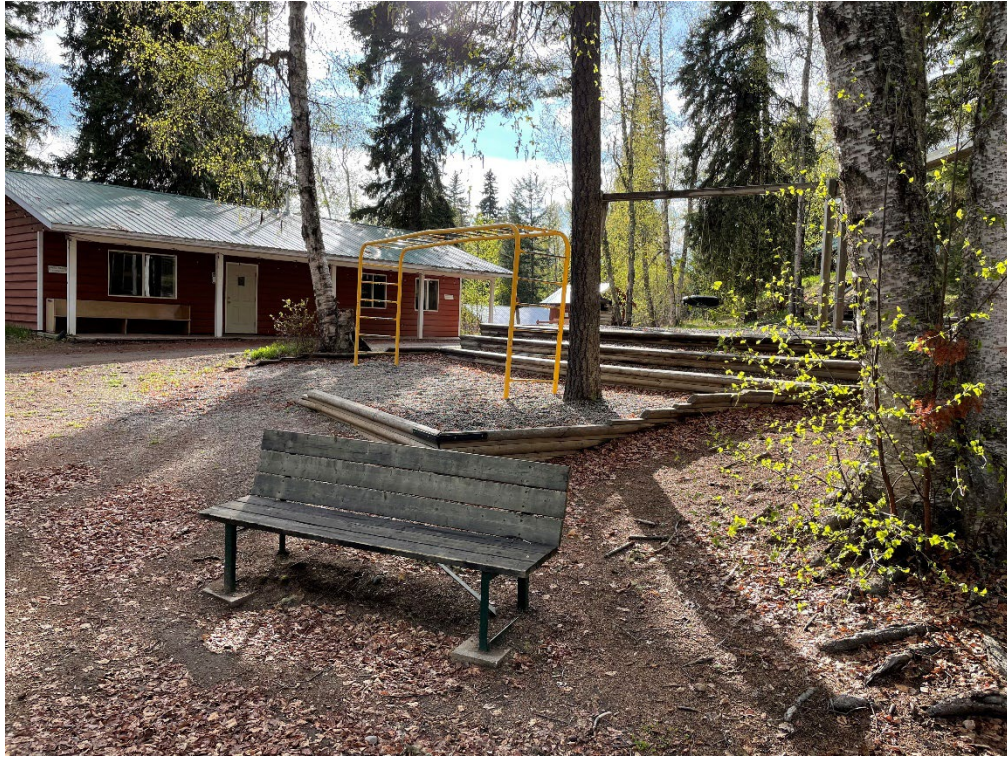
Appendix Photo A-5. Administration office and playground. Note birch tree and stump in center of photo with new vegetation establishing.

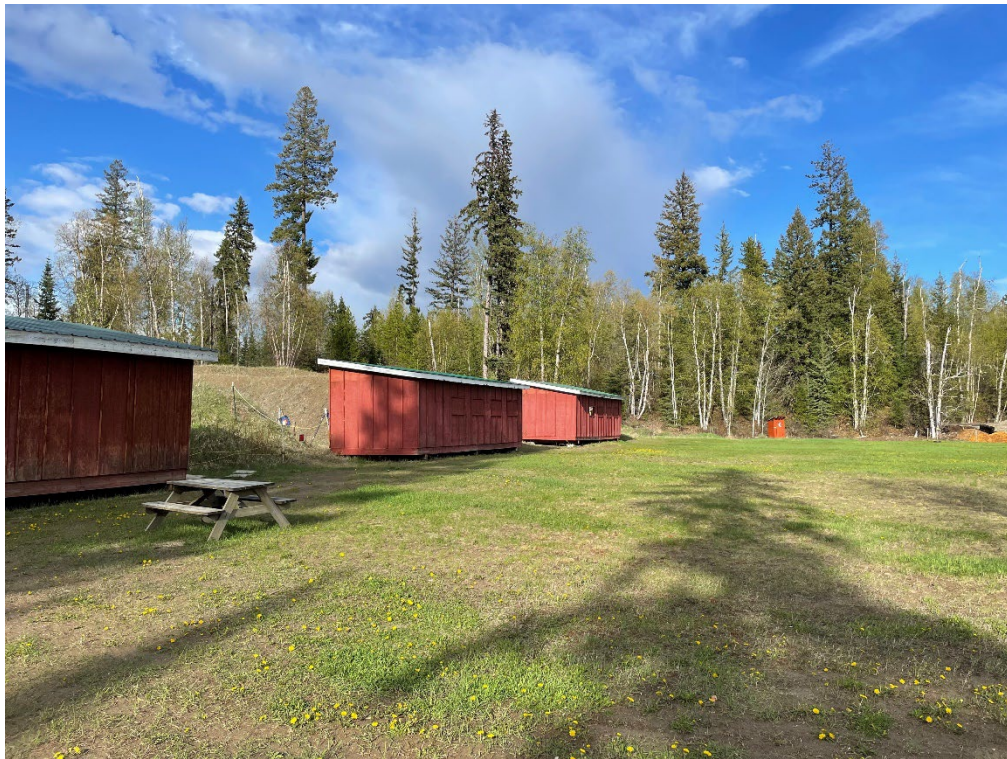
Appendix Photo A-6. .22 rifle and archery ranges. The primary septic field for the camp is under the flat grass area on the right side of photo.

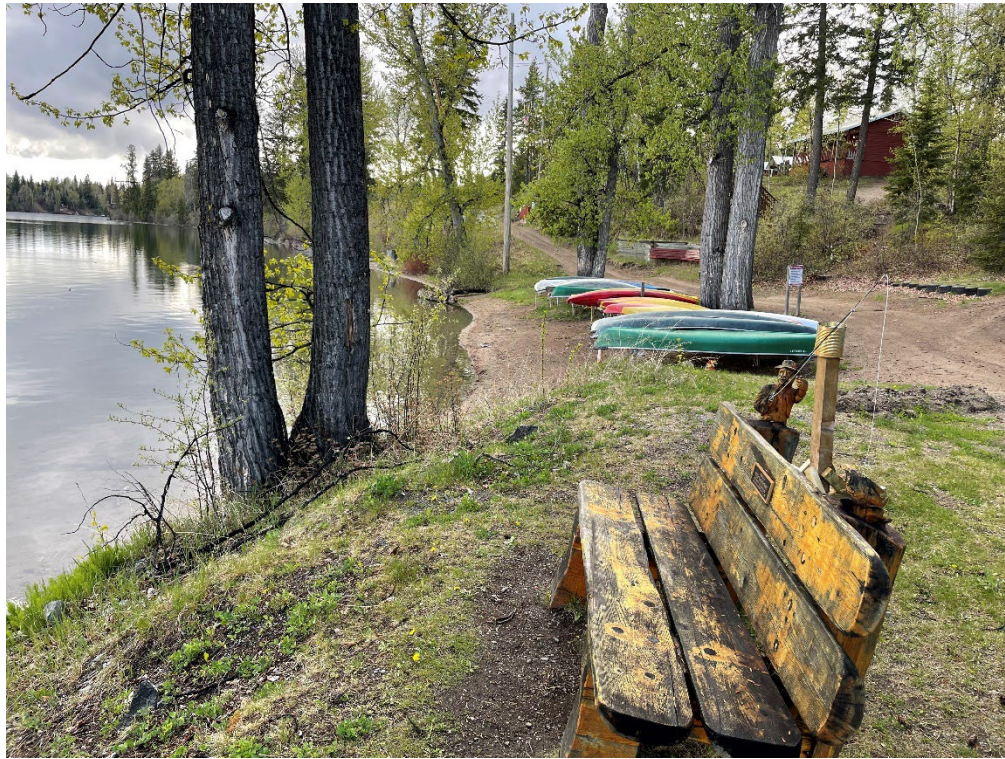
Appendix Photo A-9. Canoe rack. Note mature black cottonwood trees in the riparian area.

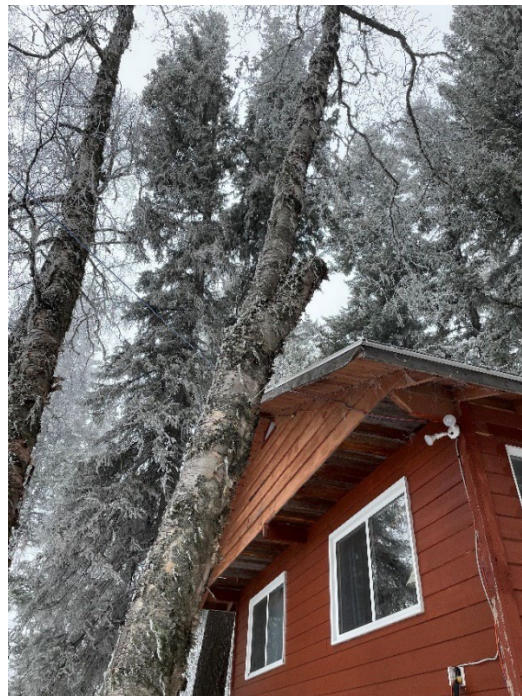
Appendix Photo A-10. Mature birch trees commonly found throughout the camp. Note the cut branch that once leaned over the cabin. It is likely that this entire tree will need to be cutdown in the future since it is leaning toward the cabin.

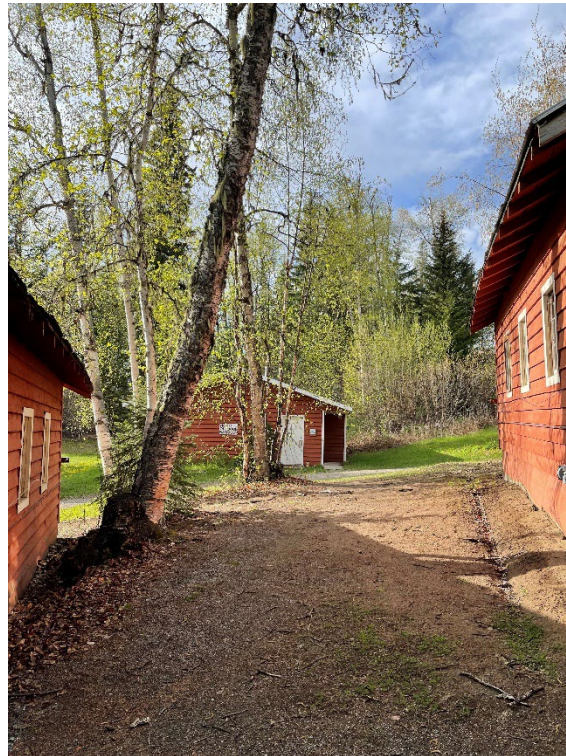
**Appendix Photo A-11.** Mature birch trees commonly found throughout the camp. Note the stump directly beside the mature birch tree and the immature conifer establishing at this site. It is likely that this large stem that is leaning toward the cabin will need to be cutdown in the future, but the three smaller stems in the same root mass will be retained.

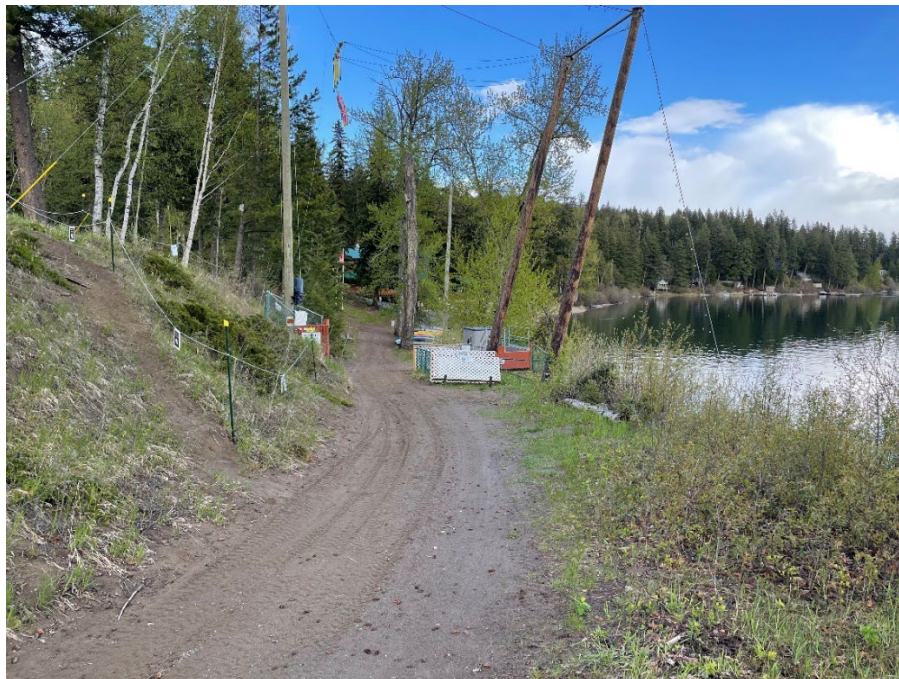
**Appendix Photo A-12.** East view towards beach. Note common juniper in roped off areas on the left (this is Restoration Site 2) and the shrubs growing on the right within the 15m riparian zone. Three water bars and a sediment trap should be installed on this section of road.

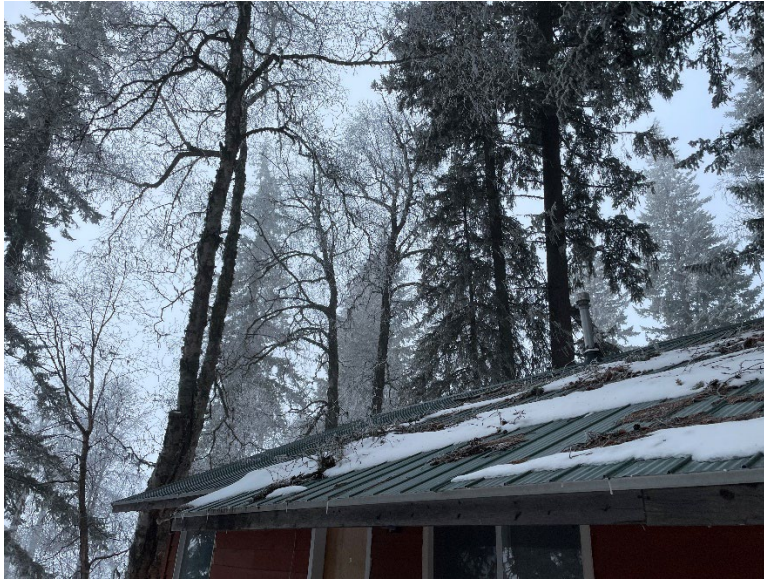
**Appendix Photo A-13.** Broken limbs from birch trees on cabin roof.

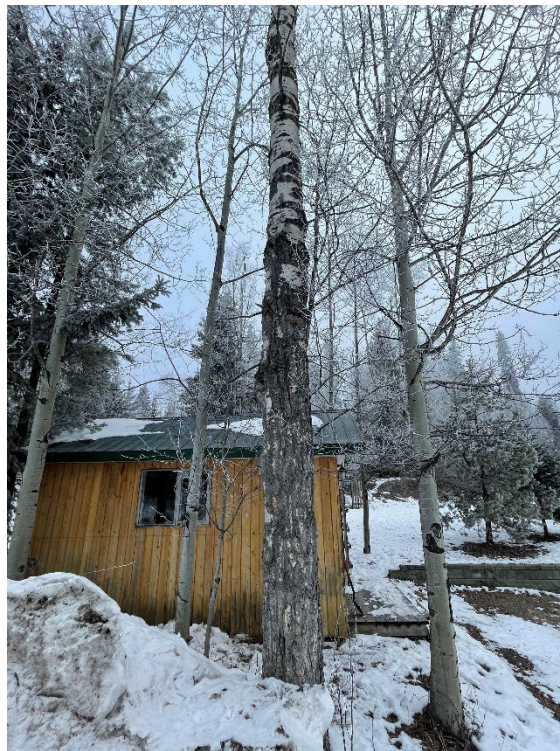
**Appendix Photo A-14.** Trembling aspen tree that has visible signs of rot (conks present) near cabin. As a safety measure, this tree will need to be removed.

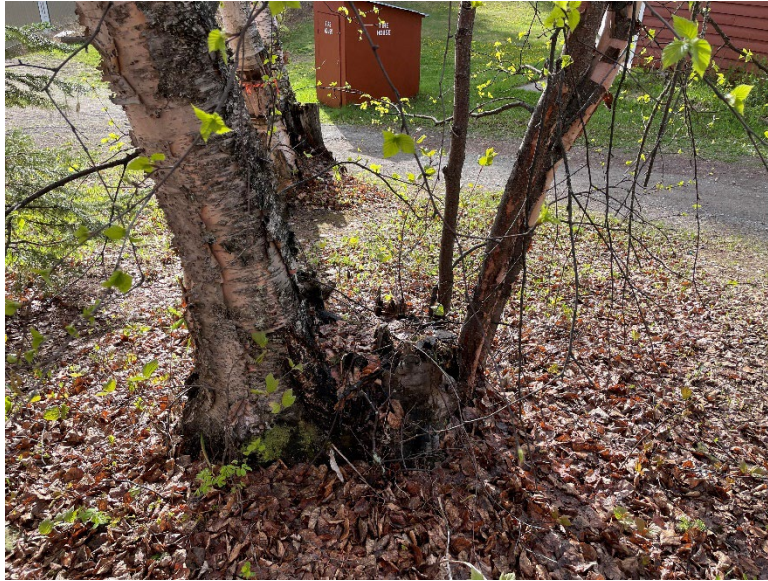
**Appendix Photo A-15.** Rotten mature birch stem removed with healthy stem left. This has provided a growing site for new stems and other plants.

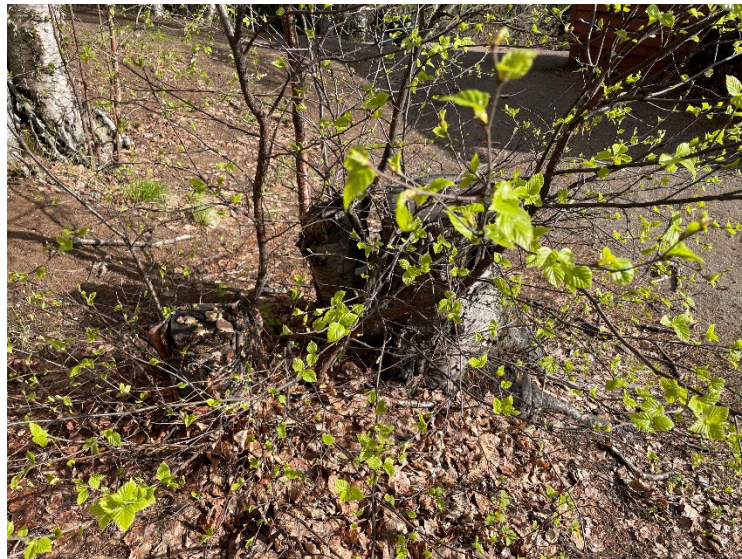
**Appendix Photo A-16.** All mature stems of this birch were rotten and needed to be removed for safety. The root mass and stumps were left in place and now have created a growing site for new vegetation to establish.

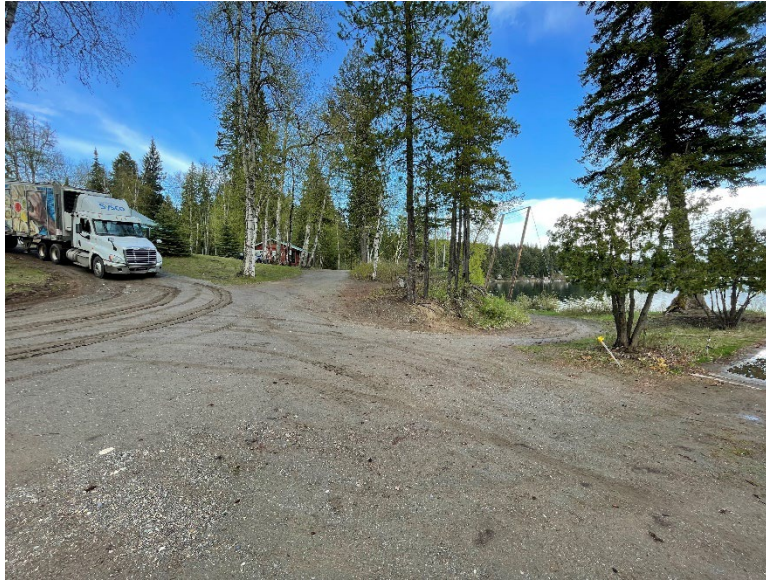
**Appendix Photo A-17.** Road maintenance is required to make sure the road surface is suitable for traffic and that sediment transported from the road network can't enter environmentally sensitive areas.

- Grade all roads in a manner that will shed runoff water toward natural drainage areas and depressions as much as possible. Where possible, road surfaces should be crowned, and windrows (grader berms) should be avoided especially on roads that have reasonably sized catchment areas or roads that lead directly towards Ness Lake. The goal is to limit the concentration of flowing water, so it does not have the power to cause significant erosion and result in the deposition of

- Remove sediment buildup from water bar channels and ditches as required.
  - Repair or reconstruct damaged water bars promptly.
  - Regrade the road surface as needed to maintain the proper crown or slope.

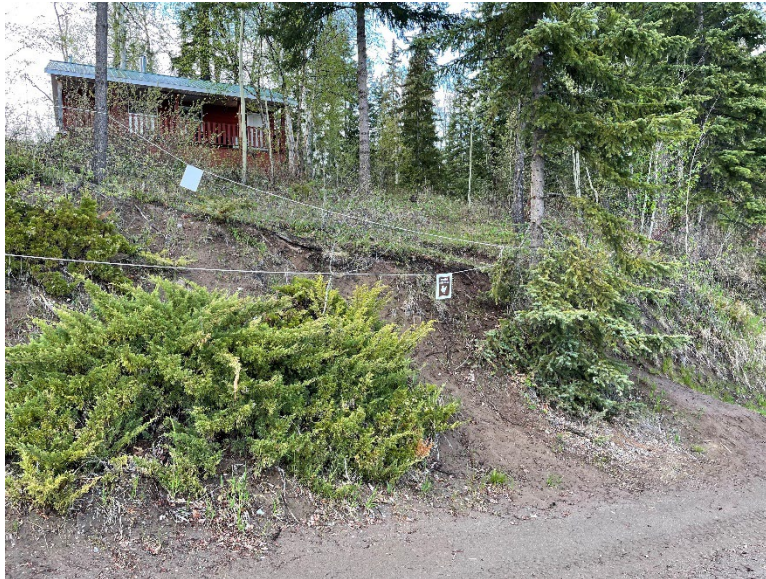
A section of slope directly uphill from the road section that provides access to the west end of the beach has been damaged by foot traffic. Soil erosion and a loss of vegetation is evident. The site has been cordoned off with rope to restrict access. The site is approximately 20 m long by approximately 5 to 10 m wide. It should be noted that a lot of vegetation is still growing on this slope, but the area where foot traffic was focused has been impacted and erosion of the sandy soil was prevalent. The most common vegetation present at this site was common juniper with lesser amounts of kinnikinnick, soopolallie, Rocky Mountain juniper and Douglas-fir (see Appendix Photo A-12 and Appendix Photo A-20). NLBC plans on restoring this site in the spring 2026 or 2027.

Appendix Photo A-20. Slope on road that leads to beach. This site has been roped off to keep campers out and will be restored with vegetation in the future (Restoration Site 2). Note the erosion and loss of vegetation.

- Continue to cordon off the impacted area to restrict access to this site to limit further damage and erosion.
- Because the site is an exposed, dry south facing aspect site with sandy soils, it will be a bit of a challenge to restore the site. It is recommended that compost is mixed into the exposed sandy soil to help retain more moisture, add some additional nutrients and help reduce the surface erosion. Since common juniper is currently the dominant plant species at this site, it should be used to restore the site. Rooted stock is available from nurseries in BC. It is estimated that 30 common juniper plants will need to be planted to restore the impacted areas within this site.
- It is recommended that NLBC staff monitor the new vegetation and water the site at appropriate intervals during the first growing season to maximize the amount of vegetation that is established.

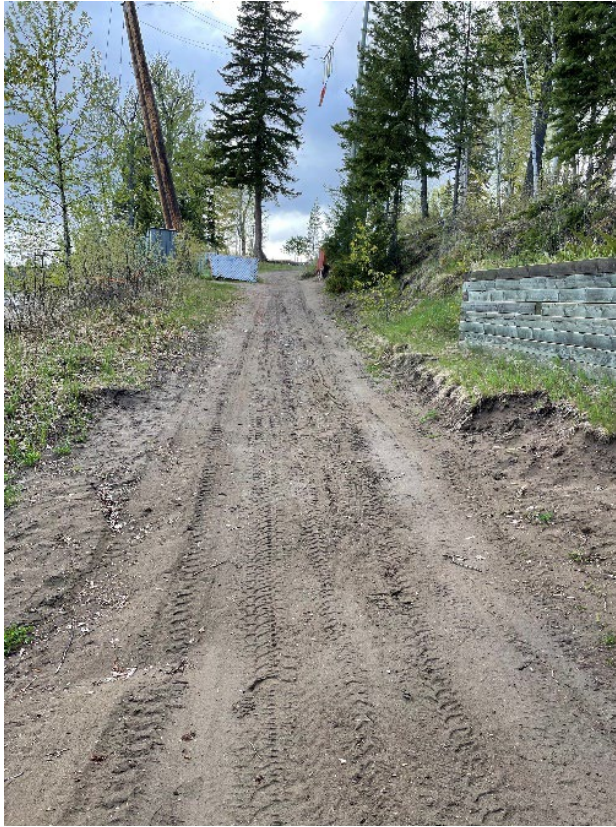
**Appendix Photo A-21.** Uphill view of road that leads to the beach. Note the sand surface that needs monitoring and maintenance, so sediment does not get transported to Ness Lake from this section of road. Three shallow water bars or berms will be installed to direct water to the roadside vegetation.

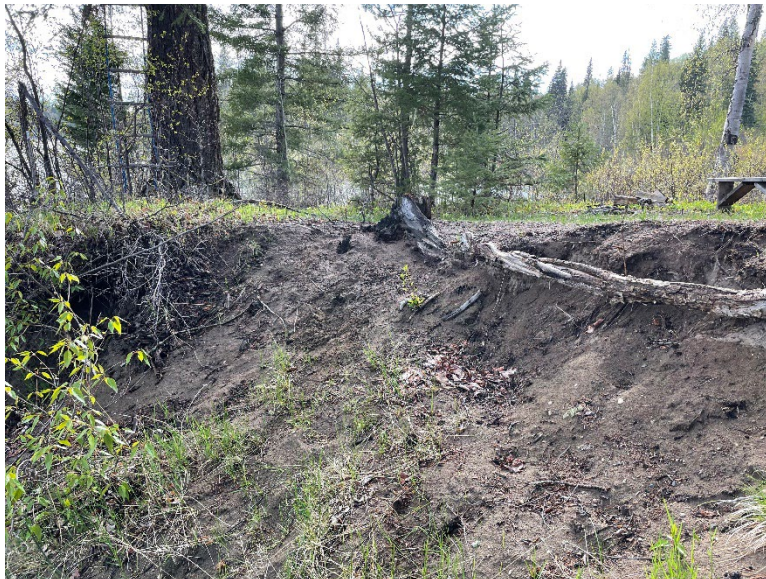
While NLBC has used its campsites for many years with minimal environmental impact, an exception exists at Campsite 9, located on the west side of the camp. At this site, foot traffic from campers has damaged a bank that leads directly to the edge of Ness Lake, causing significant erosion and the loss of vegetation on a slope within the 15 m Riparian Zone. The affected area is approximately 10 m x 10 m, though some shrubs like red-osier dogwood, alder, and Saskatoon berry, as well as a few Douglas-fir and black cottonwood trees, remain in places (see Appendix Photo A-22 to Appendix Photo A-25). To prevent further impact, NLBC has roped off this area to restrict access. NLBC plans on restoring this site in the spring of 2026.

**Appendix Photo A-22.** Crest of an eroding bank on Ness Lake at Campsite 9. Note: This campsite has been closed to campers and will be restored (Restoration Site 1).

- It is recommended that NLBC staff monitor the new vegetation and water the site at appropriate intervals during the first growing season to maximize the amount of vegetation that is successfully established.

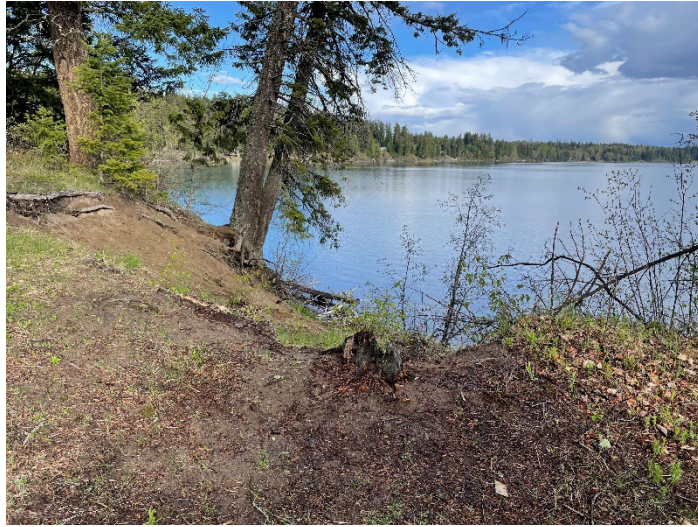
Appendix Photo A-23. Crest of eroding bank on Ness Lake (Restoration Site 1).

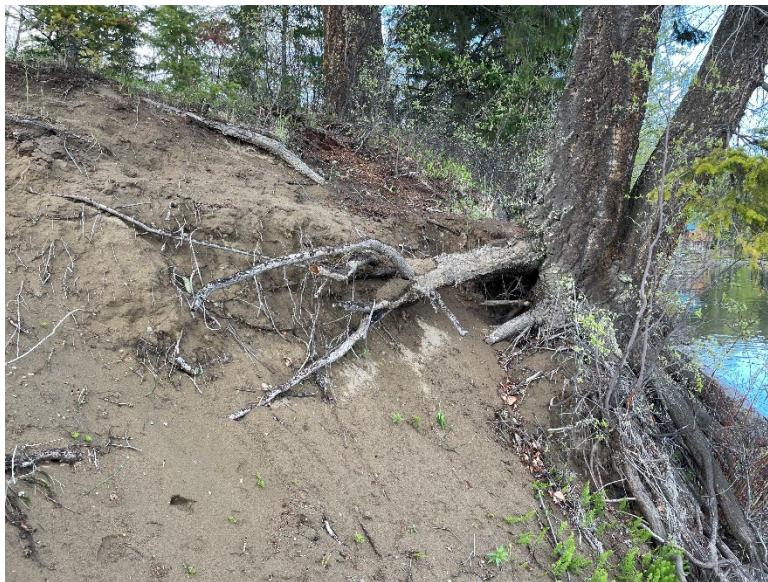
Appendix Photo A-24. Eroding bank on Ness Lake (Restoration Site 1).

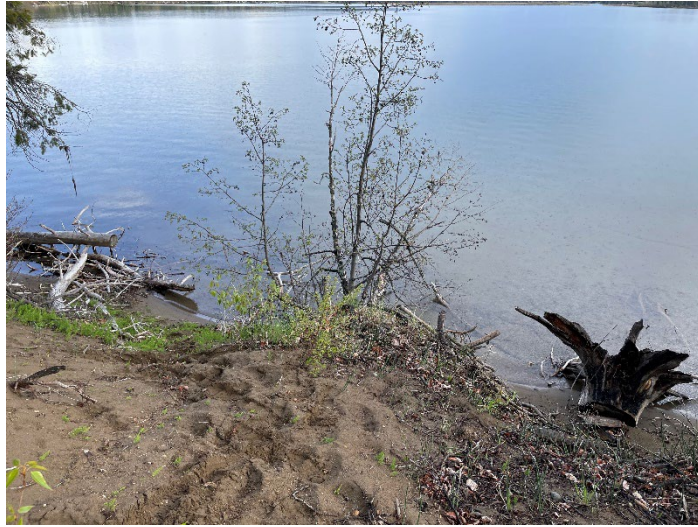
Appendix Photo A-25. Toe of eroding bank on Ness Lake (Restoration Site 1).
