## Assessment & Sustainable Replacement Options

Passenerge SkegtoRanos George (RDFFG) Prepared by: McCuaig & Associates Engineering Ltd. Date: February 20, 2024

## **Building Description**

155 George Street, Prince George, BC

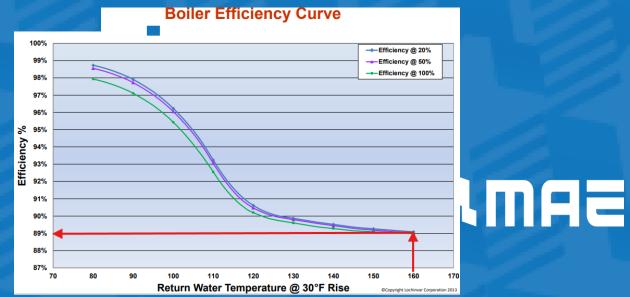
- 6 condensing boilers, ~270 MBH each
  - 2 IBC boilers installed in 2021. Good Condition
  - 1 Lochinvar installed in 2021. Good Condition
  - 3 HydroTherm boilers original to the building. Poor condition
- Issues:
  - Operating at non-condensing temps (~180°F).
  - Coupled DHW prevents lower return temps.
  - Three boilers used only for backup in extreme cold.

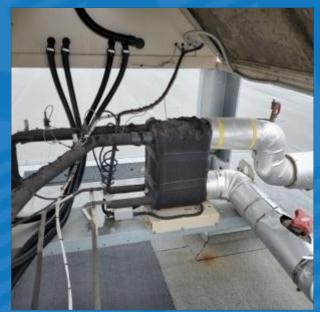
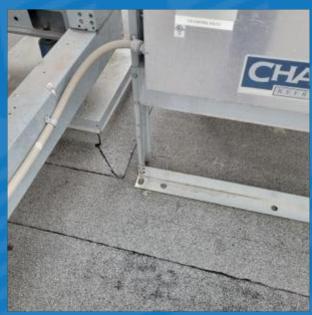
- 50-ton Daikin chiller installed in 2016 Good Condition
- Fluid cooler from 2007 (near end of life) Acceptable Condition
- Issues:
  - Chiller pipe and HX insulation are damaged (likely birds)
  - Fluid cooler is not properly fastened

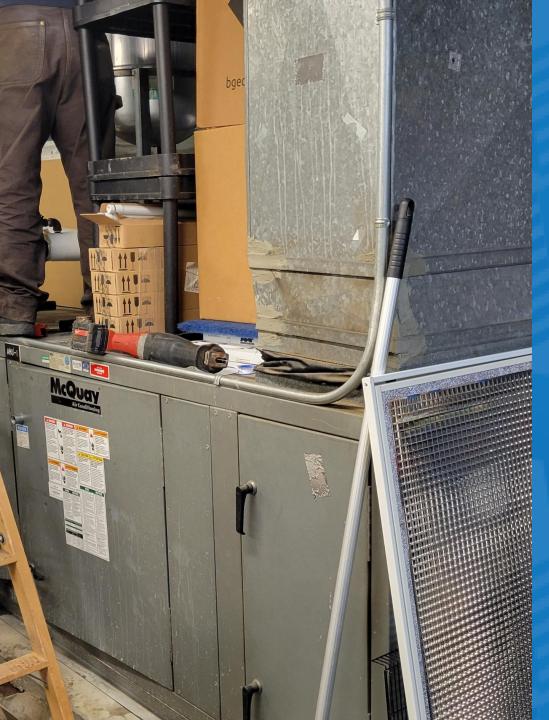
- Single Custom Maid McQuay AHU
- Issues:
  - Originally installed and reached its end of reliable service life
  - Significantly oversized. The unit is 10,000 cfm, while ASHRAE 62.1 (Ventilation in commercial buildings) only requires 3,000 cfm
  - The Oversizing is the reason of the poor performance of the generally well-maintained building

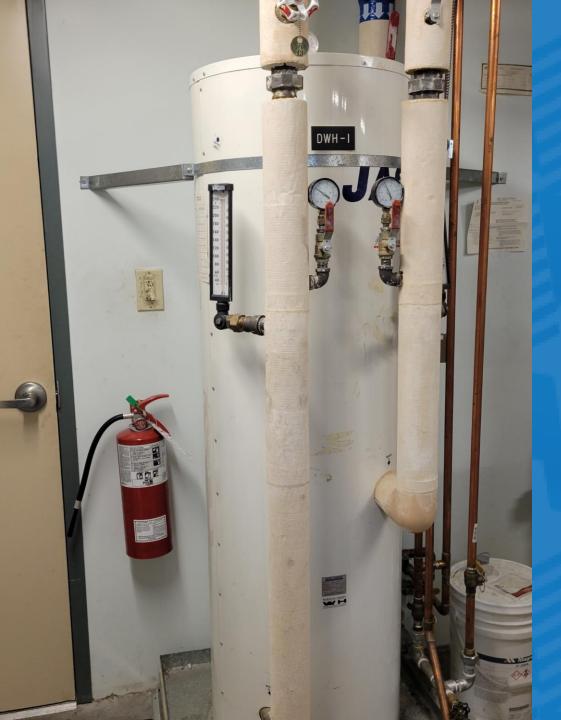
- One storage tank heater by the boiler plant
- One electric tank heater
- Issues:
  - Both reached the end of reliable service life
  - The storage tank is connected to the boiler plant, preventing it from working in a condensing range and decreasing overall efficiency

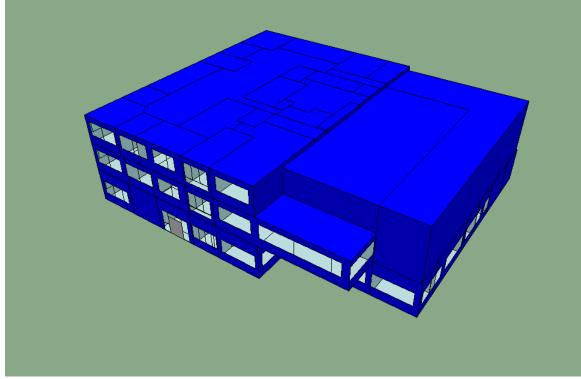
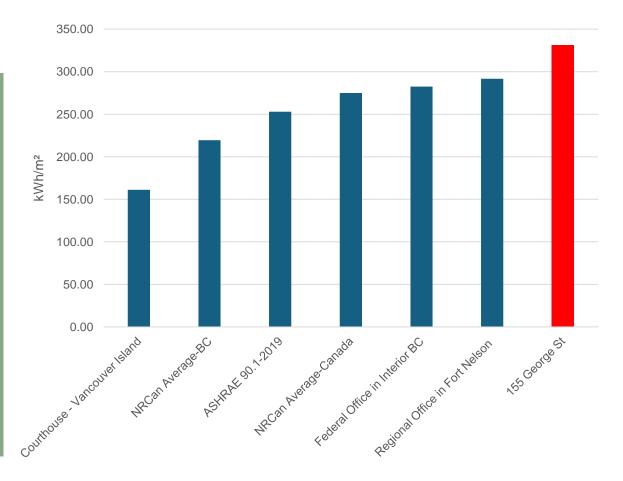
# ENERGY MODEL

SCENARIO	BASELINE – UTILITY BILLS	BASELINE - SIMULATED	MAE	CVRMSE
Gas Consumption (kWh)	567,305.81	567,612.10	0.05%	14%
Electricity Consumption (kWh)	375,800.00	365,742.90	-2.7%	5%
